Florida Engineering LLC

4161 Tamiami Trail, Suite 101, Port Charlotte, FL 33952-9204

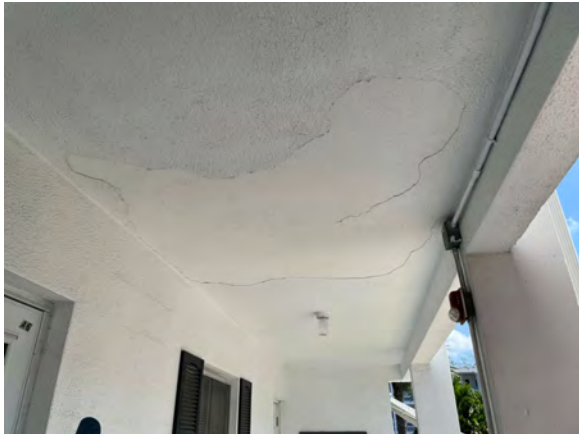
EXAMPLE OF PAINT PEELING

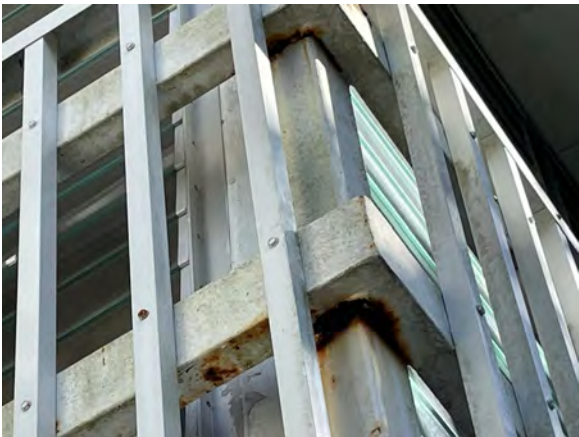
EXAMPLE OF RUSTED RAILS/BRACKETS ON BALCONY

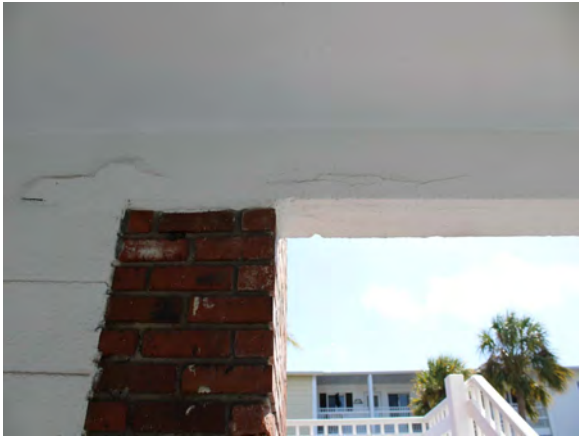
EXAMPLE OF CRACKED/SPALLED SUPPORT BEAM

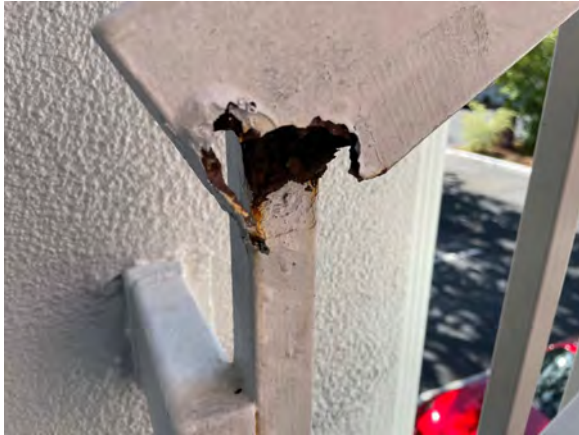
EXAMPLE OF RUSTED/DETERIORATED HANDRAIL

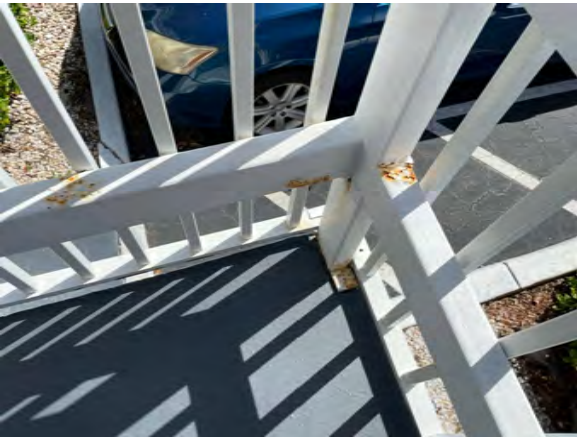
EXAMPLE OF RUSTED/DETERIORATED HANDRAIL

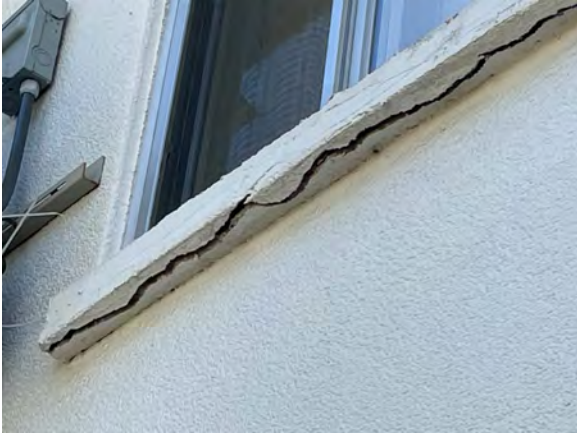
EXAMPLE OF CRACKED WINDOW SILL
