Bayshore Gardens Condo Association Unit 1 Building B

Wind Mitigation Inspection Report

By: Fair Wind Inspections Inc.

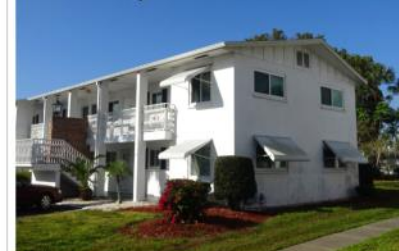
Geometry Picture

Roof Geometry:	Non-Hip		
Total Non-Hip	N/A	Total Perimeter:	N/A
Less Than 2:12:	N/A	Total Area:	N/A

Gable end walls and/or non-hip features are greater than 10% of total perimeter
