Bayshore Gardens Condo Association Unit 1 Building D

Wind Mitigation Inspection Report

By: Fair Wind Inspections Inc.

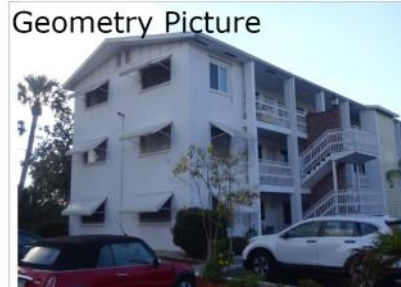
Geometry Picture

Roof Geometry:	Non-Hip		
Total Non-Hip	N/A	Total Perimeter:	N/A
Less Than 2:12:	N/A	Total Area:	N/A

Gable end walls and/or non-hip features are greater than 10% of total perimeter
