Bayshore Gardens Condo Association Unit 1 Clubhouse

Wind Mitigation Inspection Report

By: Fair Wind Inspections Inc.

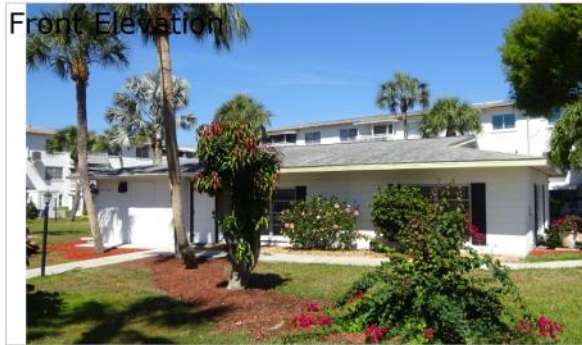
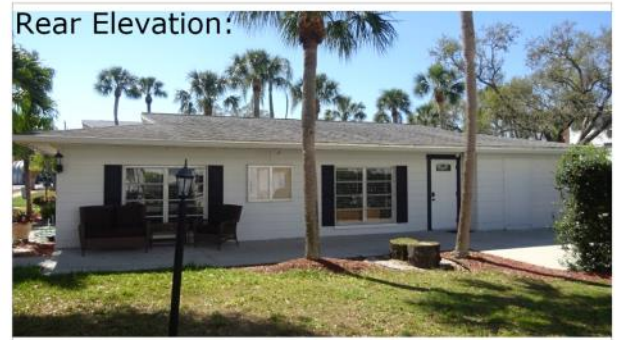
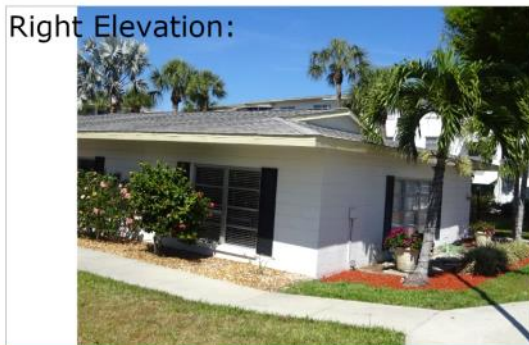
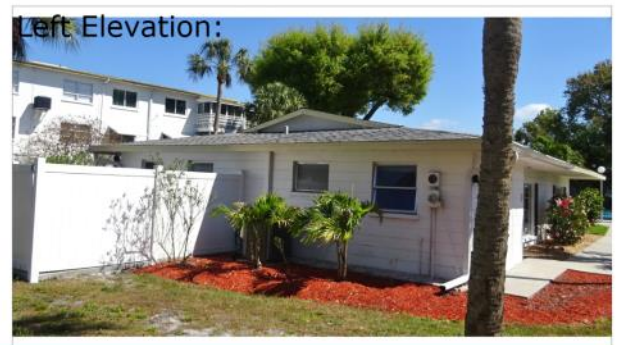
Date Replaced:	April 17, 2013
Permit With:	Manatee County
Permit Number:	CMP-13041103
Covering:	Shingles

Roof surface is in good condition

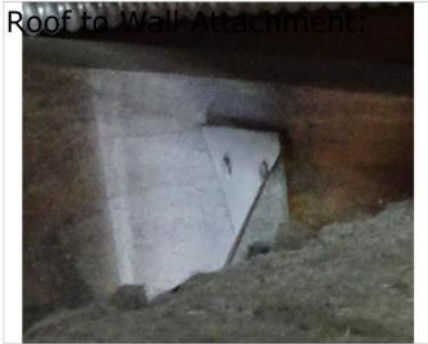
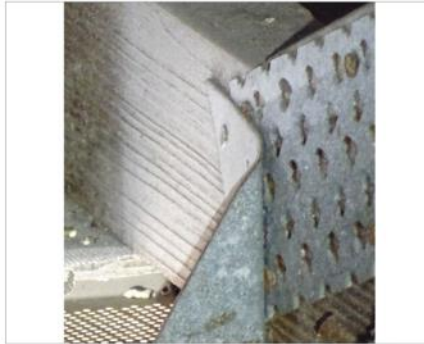
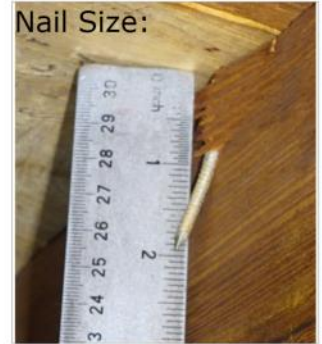
SWR Pic:

Clip Type:
 Nails Per Clip:

Notes: Clips on each truss only have 2 nails, thus must classify as a toe nail system.

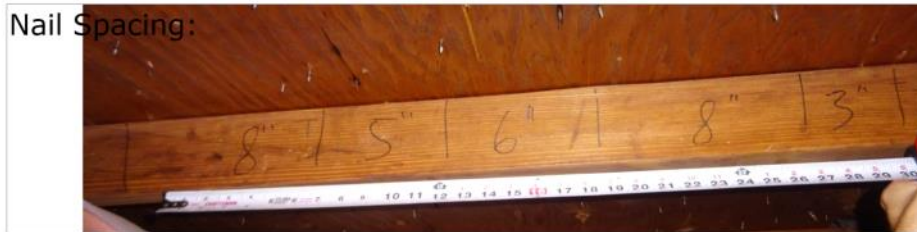
Roof Deck Thickness:

Underside of roof is in good condition
