Bayshore Gardens Condo Association Unit 1 Building E

Wind Mitigation Inspection Report

By: Fair Wind Inspections Inc.

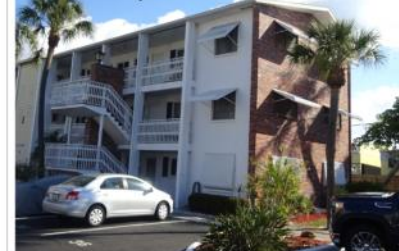
Geometry Picture

| Roof Geometry: | Non-Hip | | |

Gable end walls and/or non-hip features are greater than 10% of total perimeter
